Manhole Inspection Summary

Manhole # S49AA_028MH

Insp Date: **5/8/08 10:49 AM**

Location Address: **600 n lakewood ave**

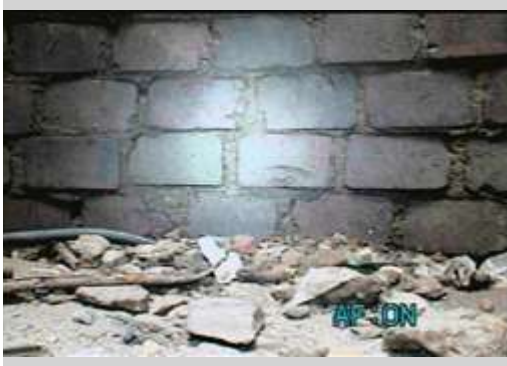
MISC

bench debris

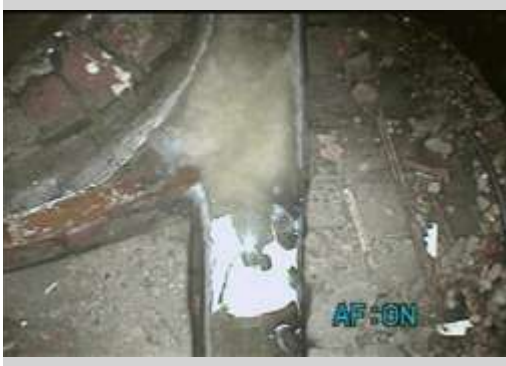
MISC

channel debris

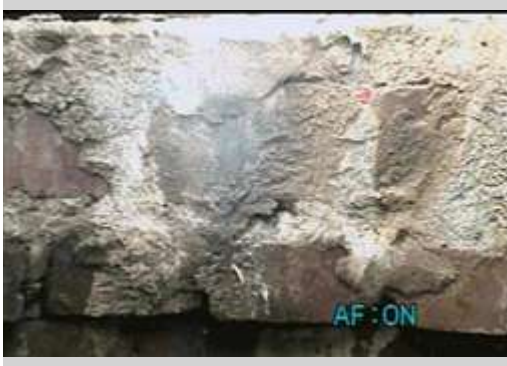
Misc

CHIMNEY_PARGED

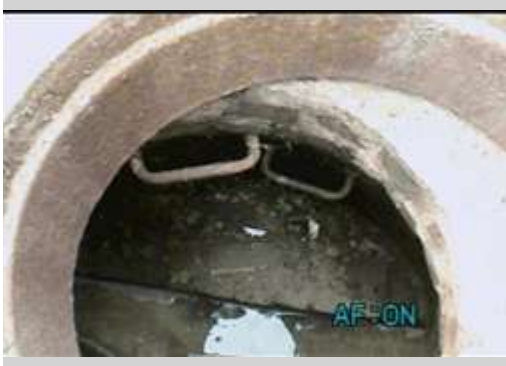
Defect 2

Steps Count: **2** Missing: **0** ☒ **Corroded**

steps

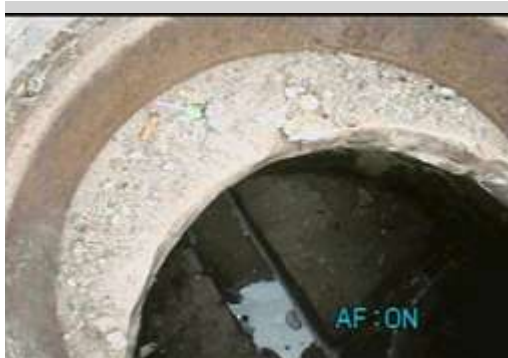
Defect 1

Frame Offset: **6** (in.) Condition: ☒ Sound ☐ Cracked ☐ Leaks

offset
